**November 20, 2023**

# MERP Level 2 Energy Assessment for

**Municipal Energy Resilience Program  
Canaan Town Office  
Canaan, Vermont**

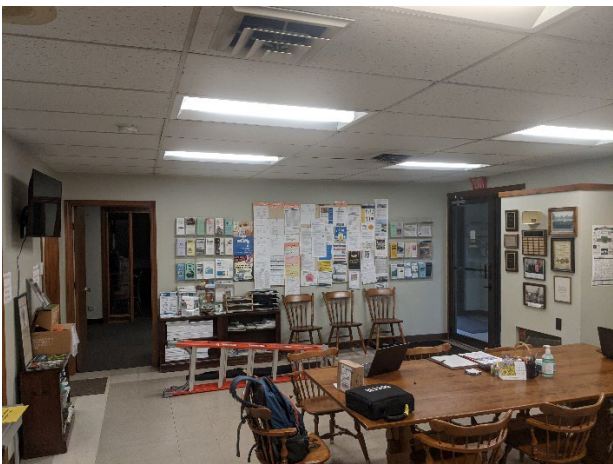
During the assessment, the major source of air leakage that was identified was at the first-floor ceiling, which separates the conditioned space from the unconditioned attic. This assembly is comprised of acoustical ceiling tiles (ACTs) and grid, an approximately 23" plenum space for electrical wiring and ductwork, and fiberglass insulation between and on top of roof trusses. This assembly lacks an effective air barrier, as neither the fiberglass insulation nor ACT ceiling is truly airtight. The ACTs themselves do not allow airflow, however each tile sits on a metal grid system and does not create an air-tight seal. Small amounts of air could be felt moving around the perimeter of each of these tiles, with larger amounts felt where tiles were not sitting firmly on the grid or where penetrations were present.

*A view of the ACT grid at the first floor ceiling. This was consistent on the first floor except for the vestibule, which had a drywall ceiling.*

The most effective way to reduce this air leakage from the 1<sup>st</sup> floor ceiling would be to install an air barrier. Installing an air barrier at the 1<sup>st</sup> floor ceiling itself would require extensive remodeling given the presence of HVAC and electrical components in the ceiling's plenum space. A simpler method to achieve this would be to shift the building's air and thermal barrier from the 1<sup>st</sup> floor ceiling to the roof plane. Utilizing a material such as closed cell spray foam on the underside of the roof sheathing would establish both an air and thermal barrier. The gable walls of the attic would also need to be insulated and the venting sealed, same with the roof soffits. This would be creating a "hot" roof and turning the attic into a conditioned space. If this approach is pursued it is critical that the installation of spray foam is of high quality. Using the appropriate material, following manufacturers installation instructions, and installing under appropriate conditions are all extremely important factors to ensure a high quality and durable final product. Issues such as cracking of the spray foam and poor adhesion to the roof sheathing could occur if not installed properly. Cx Associates recommends engaging a subcontractor that is familiar and has experience with this type of application on the underside of roof sheathing.

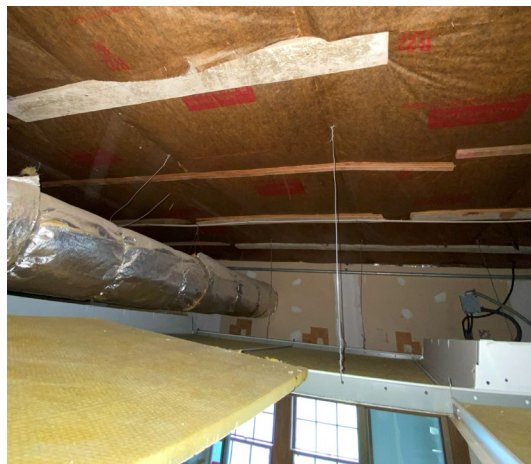
*Looking above the ACT, there is a plenum space for electrical and ductwork, then the faced fiberglass insulation is visible in between roof trusses (facing is stabled to the bottom of trusses).*

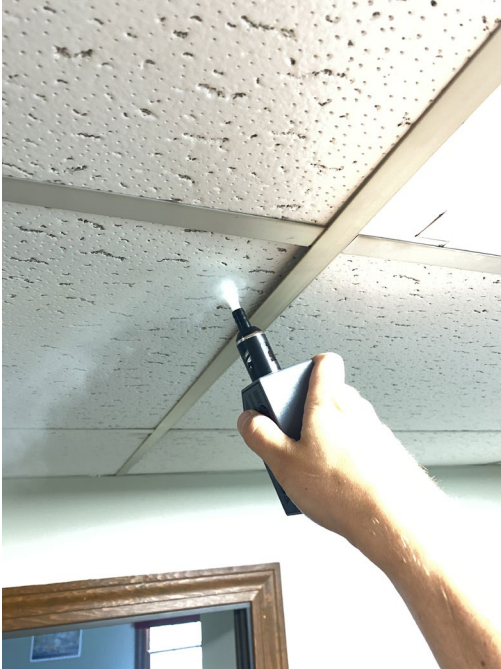
*Difficult to see in the photo, but fog is being blown down and to the left from the air movement coming through the corner of the ACT where it is not fitting tightly to the grid.*

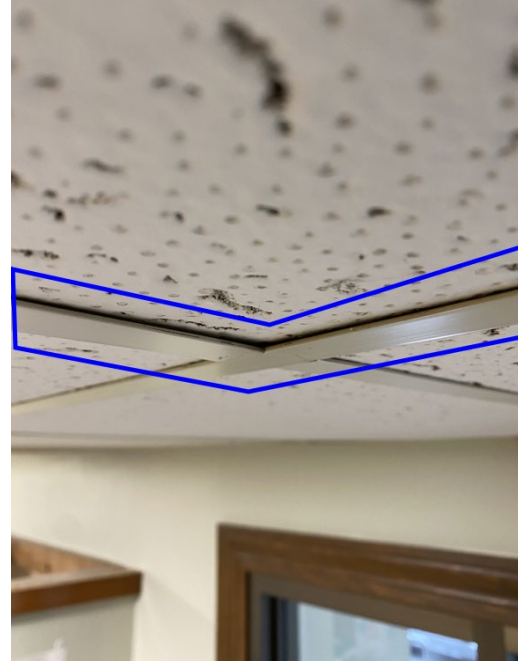
*An example of the small gaps present around the ACTs, they do not create an air-tight seal to the grid.*

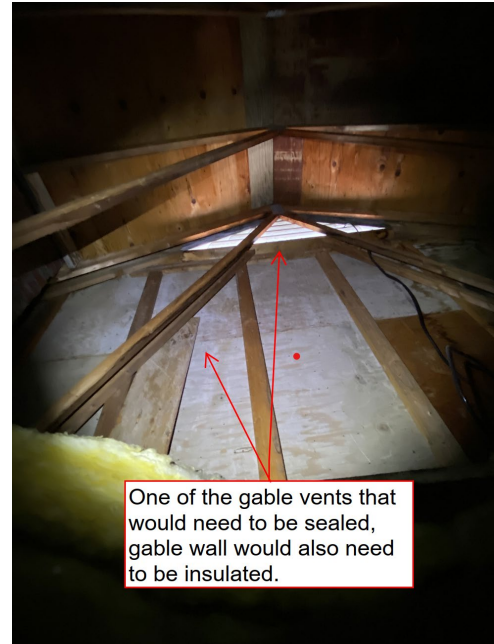
*One of the gable ends of the roof that would need to be sealed and insulated.*

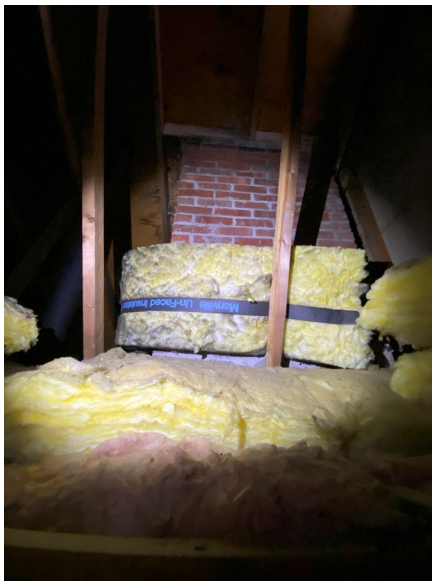
While the building was under negative pressure, a major source of air leakage was identified at the basement level, inside the mechanical/furnace room. The furnace and other exhaust fans exhaust through the original brick chimney, which extends through the roof of the building. It appears that there is no air barrier or sealing present around the chimney where it enters the unconditioned attic space, which is vented on the gable ends of the roof to allow air flow. Attic access did not allow for a close-up inspection, but fiberglass insulation was visible wrapping the base of the chimney. Fiberglass insulation improves the R-value; however it is not an effective air barrier. The lack of

sealing or air barrier around the chimney allows air to flow between the conditioned basement and the unconditioned attic space. The airflow at this location during testing was very noticeable and is assumed to be a major source of leakage.

*A view of the chimney inside the attic, partially wrapped with fiberglass insulation. Attic access did not allow closer inspection of this area.*

Cx Associates recommends that an air barrier be installed/constructed at the chimney in the attic space. This could be accomplished in a number of ways; without a closer inspection of the current conditions, it is difficult to say which would be most effective. Utilizing wood framing and sheathing to close this shaft around the chimney and then installing a layer of closed cell spray foam would accomplish both establishing an air barrier and adding R-value around the base of the chimney. Please note that if the air and thermal barrier is shifted to the roof plane as discussed in item 1 above, then this recommendation is no longer applicable. Making the attic part of the conditioned space would eliminate the concern of air leakage from the attic to the basement (however the chimney penetration through the roof would still need to be detailed to ensure air tightness).

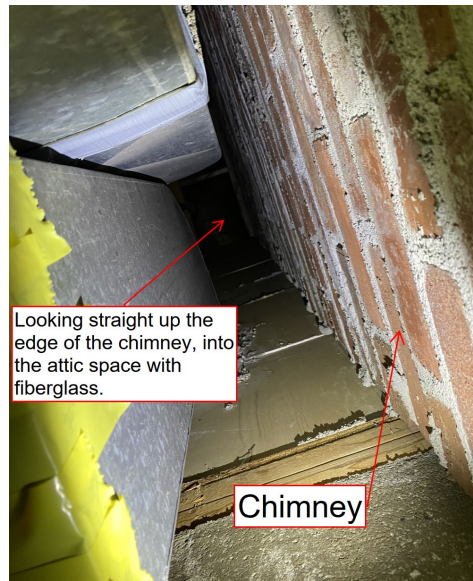
Looking straight up the edge of the chimney, into the attic space with fiberglass.

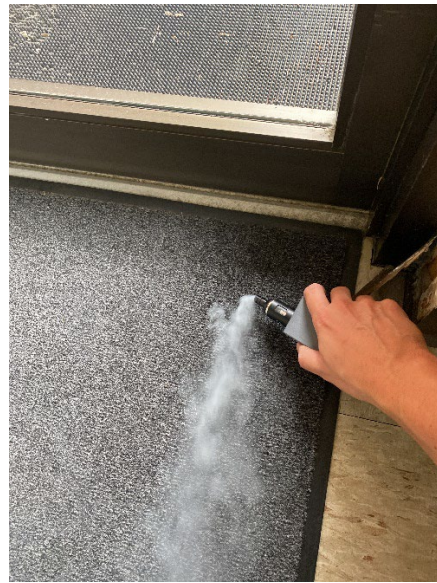
*Fog shows that a strong current of air is present at the bottom of the door. This was consistent at both exterior vestibule doors.*

To improve the performance of the exterior doors, Cx Associates recommends installing and upgrading weather stripping. The exterior doors on the first floor currently have weather stripping around the head and jambs, however it is quite worn, compressed, and dirty. Replacing this weather stripping would be relatively easy and inexpensive and would improve performance. Installing under-door weather stripping or door bottoms is also recommended at these doors. Most of the air leakage observed at these doors was around the door bottoms/thresholds. Similarly at the basement door, installing weather stripping around the entire perimeter would be an improvement.

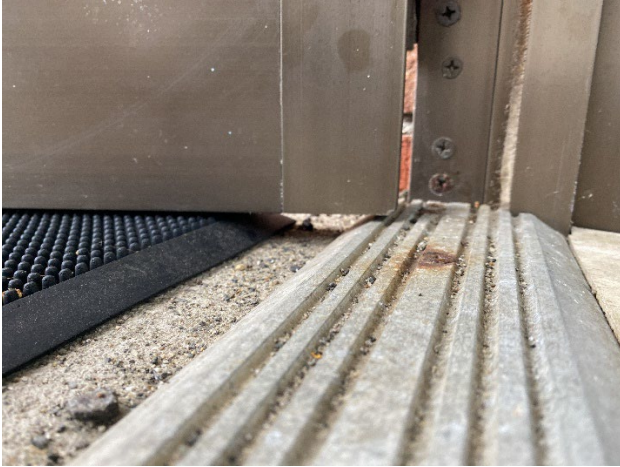
*A view of the bottom of these doors, not brush sweep or weatherstripping is present at the threshold.*

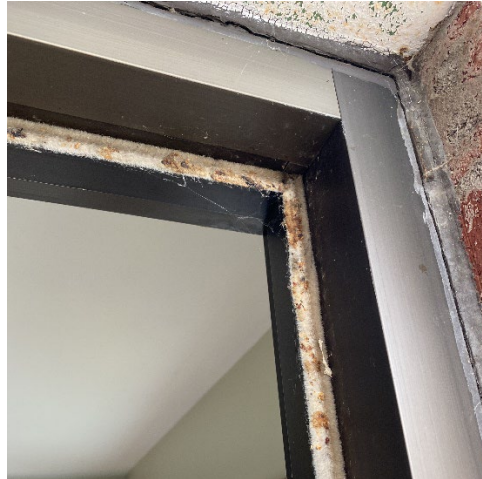
*Weather stripping was present around the head and jambs of the doors, however they were quite compressed and dirty.*

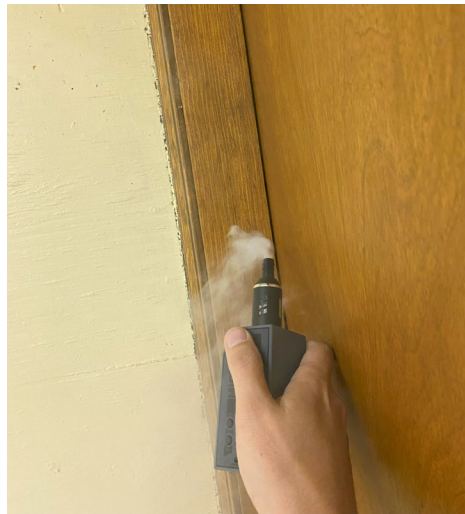
The basement door leading to the exterior bulkhead did not have any weather-stripping present. There was another door at the top of the bulkhead stairs leading to the exterior, but since the bulkhead is not a conditioned space the basement door is considered the air barrier. Air leakage at this door was consistent around the head, jambs, and threshold.

*Air was consistently observed flowing around this door, as no weather stripping was present.*

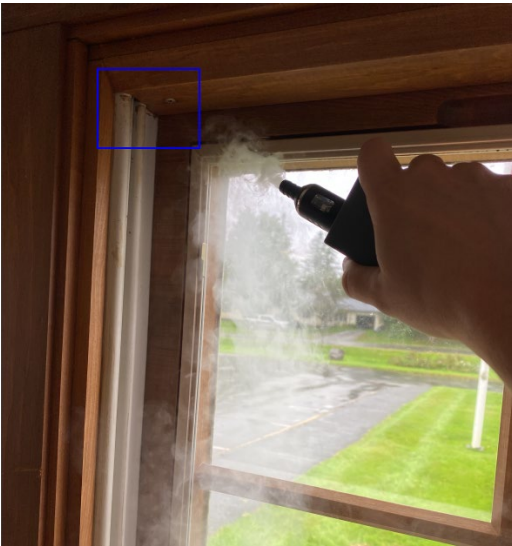
Per the staff at the town offices, the windows have not been replaced since the original construction in the 1970s. The windows all appeared to be functioning properly, all could be closed and latched for the blower door testing. Some windows had more air leakage than others, however typically leakage was observed around the operable sashes, the storm inserts, and in the upper corners. Some windows also had cracks in the glazing.

*The top corners of windows was a consistent point of leakage. Each operable window has a small opening in the corner where the pully system penetrates this frame, this appeared to be a path for air flow.*

Air leakage around the windows was fairly consistent, although it was not as significant as what might be expected for 50+ year old windows. Replacing these windows with newer, more modern windows would be the most effective way to reduce air leakage and improve overall performance, however this typically results in long payback periods given the price of new windows and their installation. Cx Associates recommends an alternative option which would be interior window inserts. These inserts can be customized to fit snugly into the existing window openings to create a tight seal. If sized and installed properly this would reduce air leakage at the windows, and slightly improve their R-value. As shown in Table 1, window inserts have a relatively high cost and low ROI, but this is only a fraction of what could be expected if a full window replacement was considered.

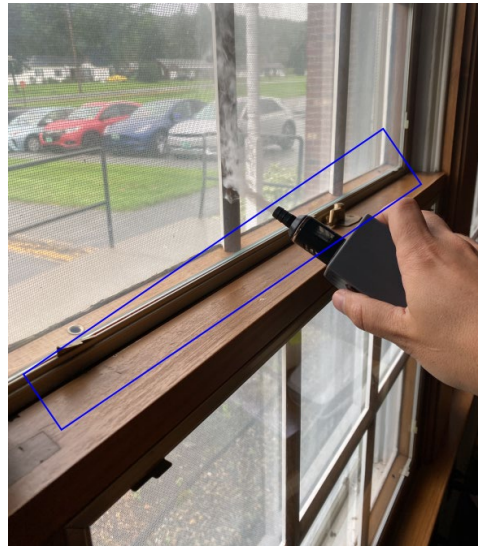
*Along operable sashes was another location where leakage was consistently observed. This is common in operable windows, as it is difficult to create a tight seal between operable components.*

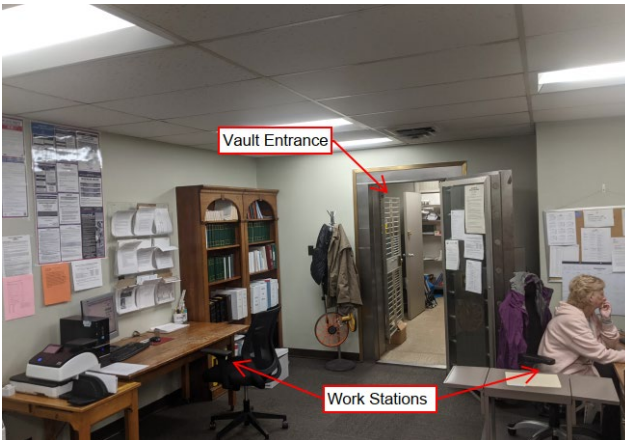
A concrete vault is located on both the first floor and at the basement level. Since these vaults are solid concrete with very few penetrations there was minimal air leakage observed. However, occupants did comment that the vault on the first floor becomes quite cold during the winter months. Looking at the building's original construction drawings, it shows that the first floor vault is 18" of concrete with only 1" of rigid insulation on the exterior behind the brick façade. This

creates an assembly with a relatively low R-value (R-8), especially for an area that does not have any heating. Typically the fault remains closed, however once the concrete becomes cold it can lower the temperature of the adjacent areas as well.

*The 1<sup>st</sup> floor vault is adjacent to the works stations set up in the office area. In the winter, occupants feel the cold air from the vault.*

Increasing the R-value of the vault on the exterior would require major remodeling and would not be a cost-effective solution. Adding a heating component to the vault would increase energy consumption, and likely impact the security/protection requirements of the space. Cx Associates would recommend installing an additional layer of insulation inside the vault on the exterior walls to create a more effective thermal barrier. Installing additional materials would reduce the usable space within the vault, however an additional 2" of rigid insulation on the interior would raise the effective R-value from 8 to 18.

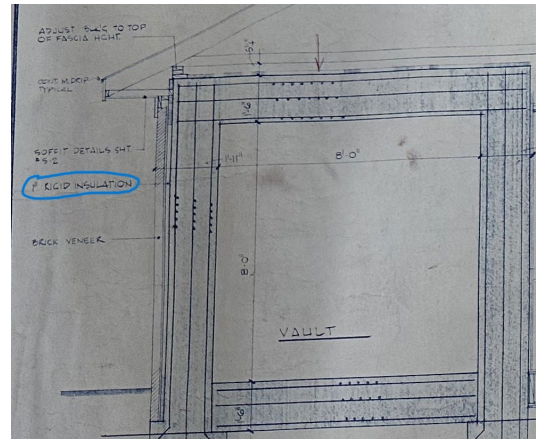
*As shown in the plans the vault is 1'6" of concrete, with only 1" of rigid insulation on the exterior behind the brick veneer.*

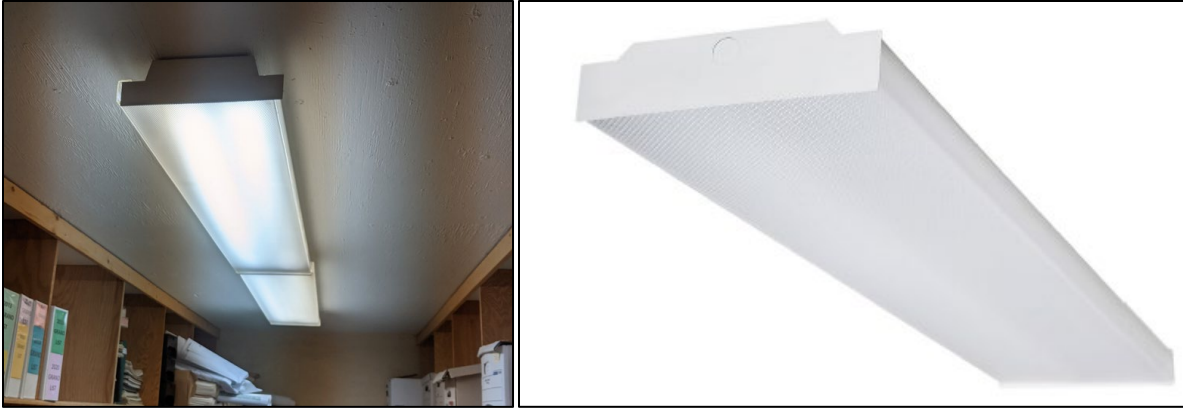
Most of the lighting in the building has already been replaced with LED retrofit kits, LED fixtures, or LED lamps. However, there are still a few remaining fixtures that we recommend be upgraded to LED, including the wraparound fluorescent T12 fixtures in the lower level (Figure 10) and incandescent bulbs in the entryway.

Figure 10: T12 wraparound fixtures in downstairs vault (left) and potential LED replacement (right)

Cx Associates recommends using retrofit kits as a minimum, as lamp-only replacements are less efficient, along with the fact that fluorescent ballasts vary and not all ballasts will work with all TLEDs.
