**November 20, 2023**

# MERP Level 2 Energy Assessment for

**Municipal Energy Resilience Program  
Canaan Town Office  
Canaan, Vermont**

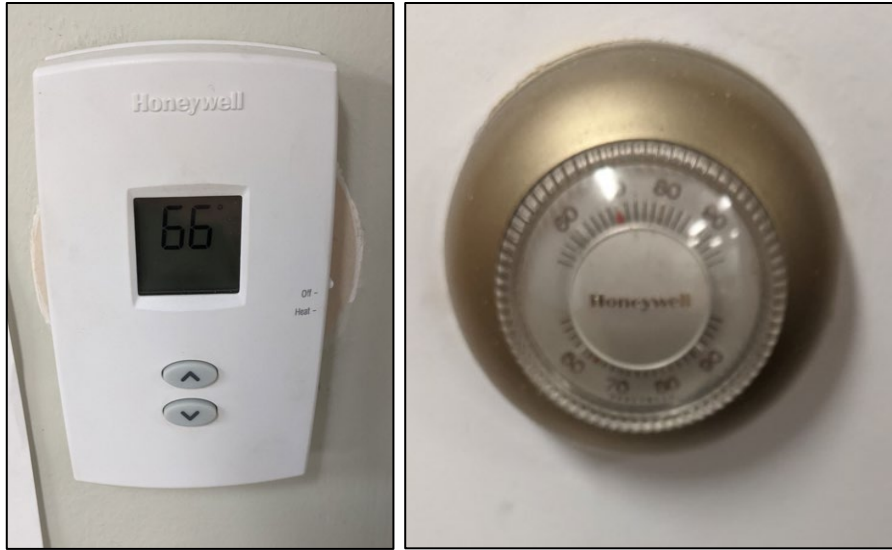
Figure 3: Building thermostats

Currently, space heating temperature setpoints are controlled manually through two wall-mounted thermostats. Building occupants indicated that the heating temperature setpoint is typically set between 68-70°F during weekdays and turned down to 67°F or so over the weekend. We recommend installing programmable thermostats to automatically enable unoccupied temperature setbacks during nights and weekends. Note that temperature setbacks are not recommended with heat pump systems, so this measure would not apply if heat pumps are installed as recommended in Measure 7.

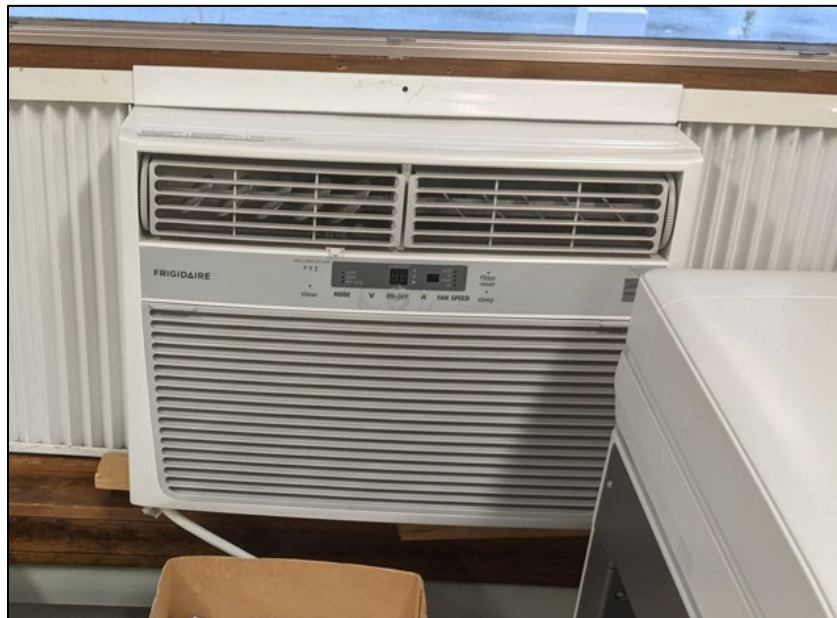
Space cooling is provided by a window-mounted air-conditioning unit located in the main office area (10,000 btu/hr capacity, 10.8 EER). This is removed during the winter months.

Figure 4: Window AC unit

The existing heating system consists of a forced-air oil-fired furnace that was replaced relatively recently. Since this system is fairly new, it may not make sense to replace it with an entirely new system at this time. One option that could result in a significant reduction in the consumption of fuel oil would be to install ductless mini-split or multi-split air-source heat pumps throughout the space. This would also have the ancillary benefit of providing cooling for the building and allow for the removal of the inefficient window air-conditioning unit.

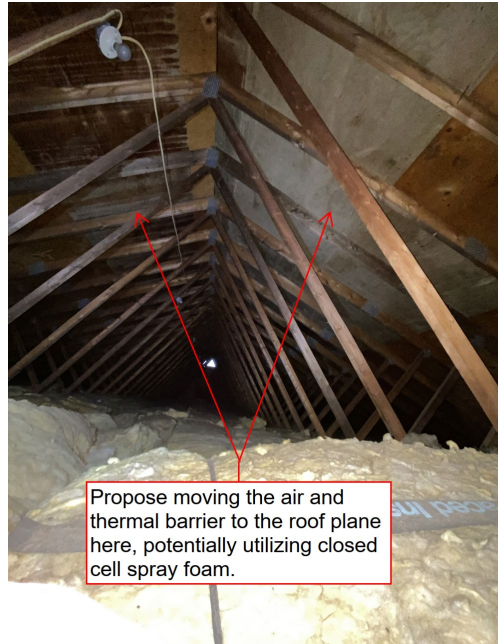
During the assessment, the major source of air leakage that was identified was at the first-floor ceiling, which separates the conditioned space from the unconditioned attic. This assembly is comprised of acoustical ceiling tiles (ACTs) and grid, an approximately 23" plenum space for electrical wiring and ductwork, and fiberglass insulation between and on top of roof trusses. This assembly lacks an effective air barrier, as neither the fiberglass insulation nor ACT ceiling is truly airtight. The ACTs themselves do not allow airflow, however each tile sits on a metal grid system and does not create an air-tight seal. Small amounts of air could be felt moving around the perimeter of each of these tiles, with larger amounts felt where tiles were not sitting firmly on the grid or where penetrations were present.

*Looking inside the attic at the underside of the roof sheathing.*

The most effective way to reduce this air leakage from the 1<sup>st</sup> floor ceiling would be to install an air barrier. Installing an air barrier at the 1<sup>st</sup> floor ceiling itself would require extensive remodeling given the presence of HVAC and electrical components in the ceiling's plenum space. A simpler method to achieve this would be to shift the building's air and thermal barrier from the 1<sup>st</sup> floor ceiling to the roof plane. Utilizing a material such as closed cell spray foam on the underside of the roof sheathing would establish both an air and thermal barrier. The gable walls of the attic would also need to be insulated and the venting sealed, same with the roof soffits. This would be creating a "hot" roof and turning the attic into a conditioned space. If this approach is pursued it is critical that the installation of spray foam is of high quality. Using the appropriate material, following manufacturers installation instructions, and installing under appropriate conditions are all extremely important factors to ensure a high quality and durable final product. Issues such as cracking of the spray foam and poor adhesion to the roof sheathing could occur if not installed properly. Cx Associates recommends engaging a subcontractor that is familiar and has experience with this type of application on the underside of roof sheathing.

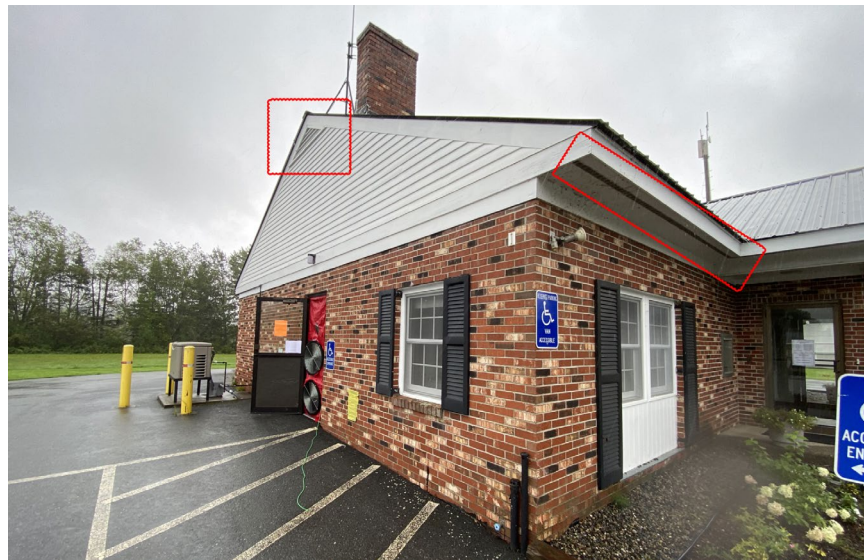
*Looking at a gable vent and soffit venting on the exterior.*

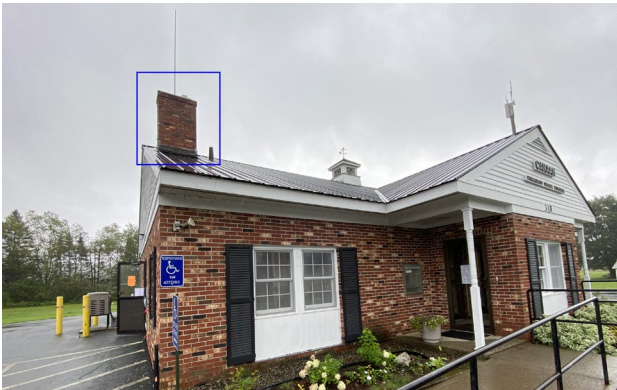
While the building was under negative pressure, a major source of air leakage was identified at the basement level, inside the mechanical/furnace room. The furnace and other exhaust fans exhaust through the original brick chimney, which extends through the roof of the building. It appears that there is no air barrier or sealing present around the chimney where it enters the unconditioned attic space, which is vented on the gable ends of the roof to allow air flow. Attic access did not allow for a close-up inspection, but fiberglass insulation was visible wrapping the base of the chimney. Fiberglass insulation improves the R-value; however it is not an effective air barrier. The lack of

sealing or air barrier around the chimney allows air to flow between the conditioned basement and the unconditioned attic space. The airflow at this location during testing was very noticeable and is assumed to be a major source of leakage.

*Chimney where mechanical systems exhaust.*

Cx Associates recommends that an air barrier be installed/constructed at the chimney in the attic space. This could be accomplished in a number of ways; without a closer inspection of the current conditions, it is difficult to say which would be most effective. Utilizing wood framing and sheathing to close this shaft around the chimney and then installing a layer of closed cell spray foam would accomplish both establishing an air barrier and adding R-value around the base of the chimney. Please note that if the air and thermal barrier is shifted to the roof plane as discussed in item 1 above, then this recommendation is no longer applicable. Making the attic part of the conditioned space would eliminate the concern of air leakage from the attic to the basement (however the chimney penetration through the roof would still need to be detailed to ensure air tightness).

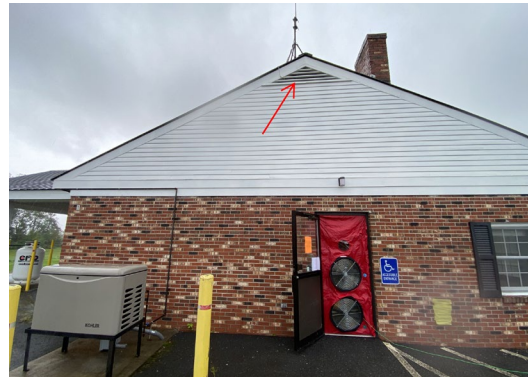
*Attic venting in the gable end of the roof.*

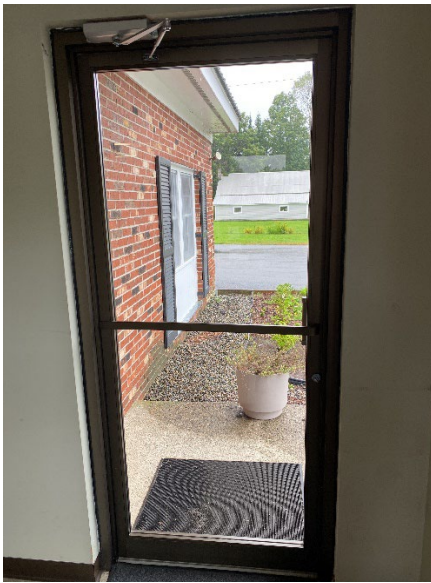
The building has three (3) doors on the first floor that lead to the exterior and one (1) door in the basement that leads to the exterior bulkhead. The two doors at the main entrance vestibule performed similarly, with minimal air leakage around the jambs and head but significant leakage around the thresholds. Weather stripping was present around the jambs and heads of these doors, but nothing was installed at the threshold. The blower door setup was installed at the northeast exterior door location so this leakage could not be observed, however the door construction is similar to the entrance doors and assumed to perform similarly.

*One of the main entry vestibule doors, similar to the side entrance where the blower door setup was installed.*

To improve the performance of the exterior doors, Cx Associates recommends installing and upgrading weather stripping. The exterior doors on the first floor currently have weather stripping around the head and jambs, however it is quite worn, compressed, and dirty. Replacing this weather stripping would be relatively easy and inexpensive and would improve performance. Installing under-door weather stripping or door bottoms is also recommended at these doors. Most of the air leakage observed at these doors was around the door bottoms/thresholds. Similarly at the basement door, installing weather stripping around the entire perimeter would be an improvement.

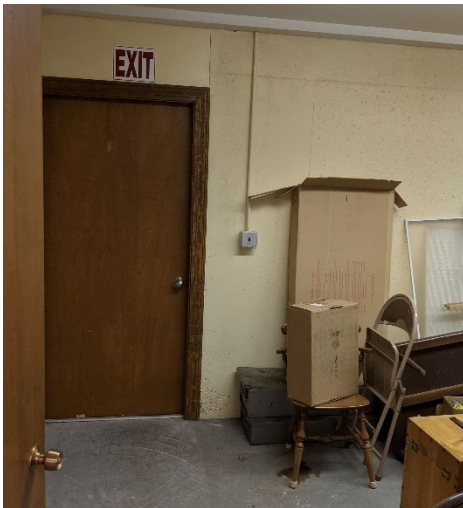
The basement door leading to the exterior bulkhead did not have any weather-stripping present. There was another door at the top of the bulkhead stairs leading to the exterior, but since the bulkhead is not a conditioned space the basement door is considered the air barrier. Air leakage at this door was consistent around the head, jambs, and threshold.

*A view of the door in the basement that leads to the exterior bulkhead.*
